Hūnua Falls Water Safety Report

OCTOBER 2022

Stanley, T. & Carmine, J. (2022). *Hūnua Falls Water Safety and Signage Report, October 2022*. Report prepared for Auckland Council and the Hūnua Falls Water Safety Project Team.

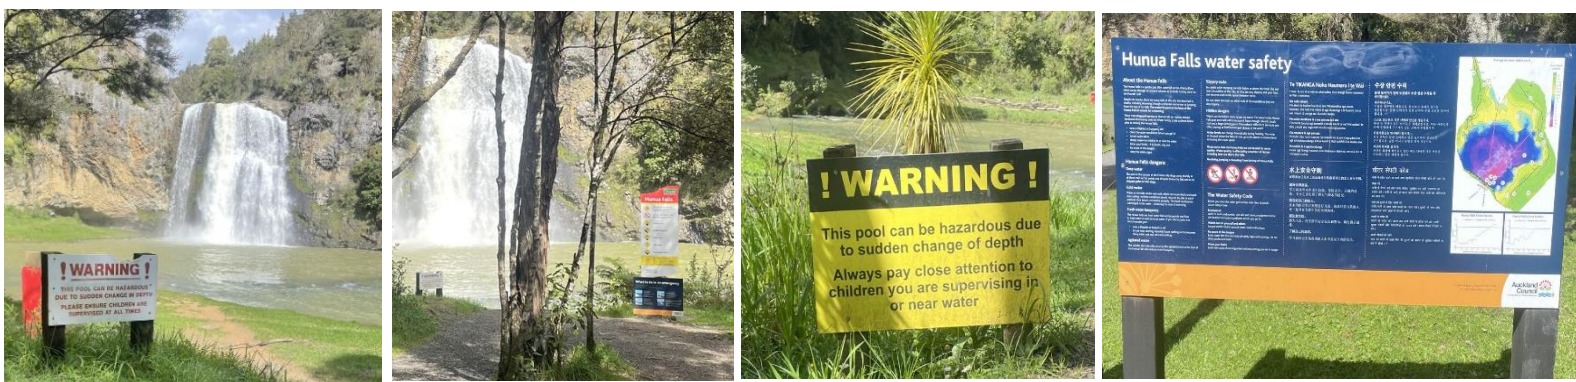
Figure 8 Examples of Signage

There is also overwhelming information on the underwater topography and swimming warning signs located near public rescue equipment use sign. The underwater topography map could suggest safer places to enter the water which may encourage site visitors to swim/bomb off sites in and around the falls. Dave Lockwood corroborated observational data recorded in Chapter 4 of this report of people seen jumping from heights of up to 15 m up the rock face of the waterfall into the deeper parts of the pool. This behaviour poses extreme danger which needs to be addressed. Effective signage could assist this.

Additionally, the current signage may provide mixed messaging with the ‘no swimming’ recommendation. Signs such as ensuring supervision of young children in and around water, use of public rescue equipment, under water topography, and what to do in an emergency suggest that being in the water is acceptable.

At present the site contains a multitude of signs which contribute to sign pollution and confusion of the essential messages. The removal of all fixed water safety signage from the site with exception to the NZ Standards compliant two white, red, and yellow signs located on the eastern and western sides of the waterhole would eliminate sign pollution and enhance the no swimming recommendation message.

The site in its current form contains an excessive amount of visual signage conveying several different messages. The excessive signage should be removed to enable clear, concise messaging about the site's history, the no swimming recommendation status, dangers, flooding potential, how to use the emergency phone, AED and life rings, and their locations in an emergency.

- Signage should be raised to facilitate reading at eye level/line of sight for ease of message delivery.
- All other signage should be removed from the water safety signage to mitigate the visual pollution, mixed messaging, and information overload of safety messaging at the track entrance and waterhole sites. The main message to be conveyed at these sites is the strong no swimming recommendation. The other information on kauri dieback, the park code, removal of rubbish, water quality, bait traps, and instructions on the emergency phone should be included on the main carpark signs.
